REPORT BMS20

Structural Properties of  
"Twachtman" Constructions for  
Walls and Floors Sponsored by  
Connecticut Pre-Cast Buildings  
Corporation

NATIONAL  
BUREAU OF STANDARDS

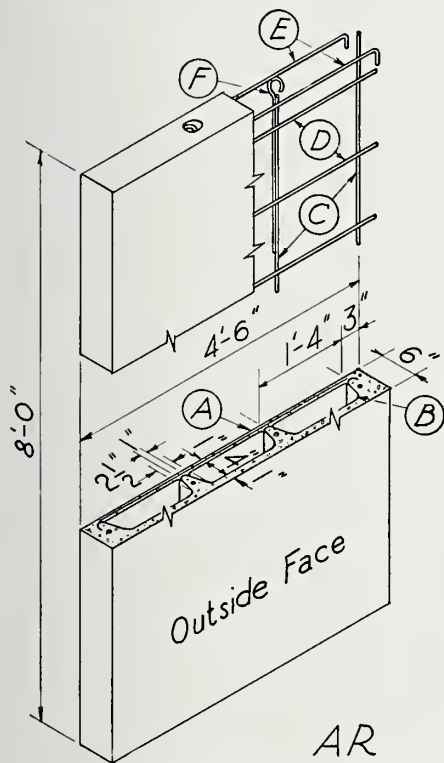
FIGURE 1.—Four-foot wall specimen AR.

A, welded wire fabric; B, metal-lath form; C, vertical reinforcement; D, lateral reinforcement; E, end reinforcement; F, eye.

reinforced-concrete slab having faces 1 in. thick and four studs integral with the faces. The specimens were cast in a horizontal position with the inside face down. Mortar was spread to a depth of  $\frac{1}{2}$  in., welded wire fabric, A, shown in figure 1, placed on the mortar, and before the mortar had set, concrete was placed over the fabric to a depth of  $\frac{1}{2}$  in., completing the inside face. A metal-lath form, B, with the reinforcement and hooks fastened in their proper relative positions by wire, was placed on the fresh concrete. The reinforcement consisted of vertical reinforcement, C, for each stud, lateral reinforcement, D, for the outside face, and end reinforcement,

E, at each end. Eyes, F, were fastened to the upper ends of the reinforcement for the two inner studs. Concrete for the studs and outside face was placed in the form, compacted by vibrators, and leveled to a depth of  $\frac{1}{2}$  in. above the top of the metal lath. The outside face was finished with mortar,  $\frac{1}{2}$  in. deep, placed on the fresh concrete, screeded, and troweled smooth.

*Welded wire fabric.*—The welded wire fabric, A, was one sheet 7 ft 10 in. by 4 ft 0 in.

*Metal-lath form.*—The metal-lath form, B, consisted of four strips 6 ft 0 in. by 2 ft 0 in., and one strip 6 ft 0 in. by 1 ft 0 in. The length of the strips was at right angles to the length of the specimen. The strips overlapped about 2 in. and were shaped by dies to the form of the studs.

*Vertical reinforcement.*—The vertical reinforcement, C, consisted of one  $\frac{3}{8}$ -in. diam reinforcement bar, 7 ft 6 in. long, in each stud, at midthickness.

*Lateral reinforcement.*—The lateral reinforcement, D, consisted of eight  $\frac{1}{4}$ -in. diam reinforcement bars, 4 ft 2 in. long, spaced 1 ft 0 in. on centers, and  $\frac{1}{2}$  in. below the outside face.

*End reinforcement.*—The reinforcement, E, at each end consisted of two  $\frac{1}{2}$ -in. diam reinforcement bars, 4 ft 8 in. long, having 3-in. right-angle bends at each end. The bars were spaced about 5 in. on centers and about 1 in. from the ends of the specimen.

*Eyes.*—There were two lifting eyes, F, at the upper end of each specimen. The eyes were  $\frac{1}{2}$ -in. diam reinforcement bars, 3 ft 0 in. long, with one end bent to a ring, 3 in. diam. Each eye was in a recess in the end of the specimen.

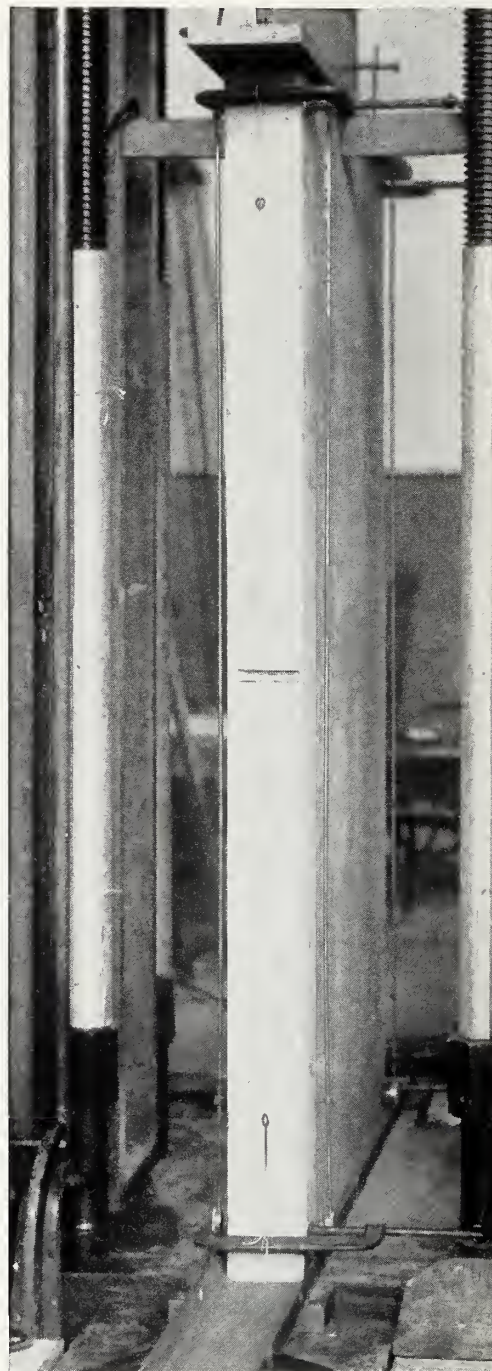
FIGURE 2.—Wall specimen *AR-C1* under compressive load.

Wall specimen *AR-C1* under compressive load is shown in figure 2. The results for wall specimens *AR-C1*, *C2*, and *C3* are shown in table 2 and in figures 3 and 4.

Specimens *C1* and *C3* failed by crushing of the upper ends of the specimens, cracking of the outside faces transversely (across the specimens) near the upper ends, and cracking ver-

tically at the edges near the upper ends. Specimen *C2* failed by crushing of the lower end.

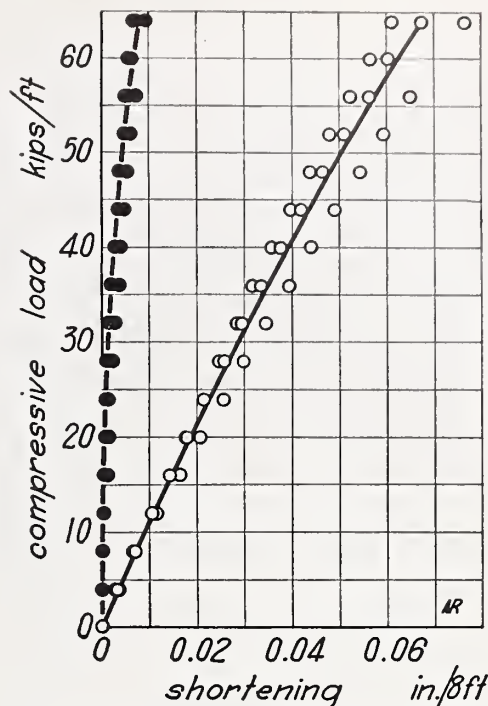
The shortenings and sets shown in figure 3 for a height of 8 ft were computed from the values obtained from the compressometer

readings. The gage length of the compressometers was 7 ft 6 in.

FIGURE 3.—*Compressive load on wall AR.*  
Load-shortening (open circles) and load-set (solid circles) results for specimens *AR-C1*, *C2*, and *C3*. The load was applied 2 in. from the inside face. The loads are in kips per foot of actual width of specimen.

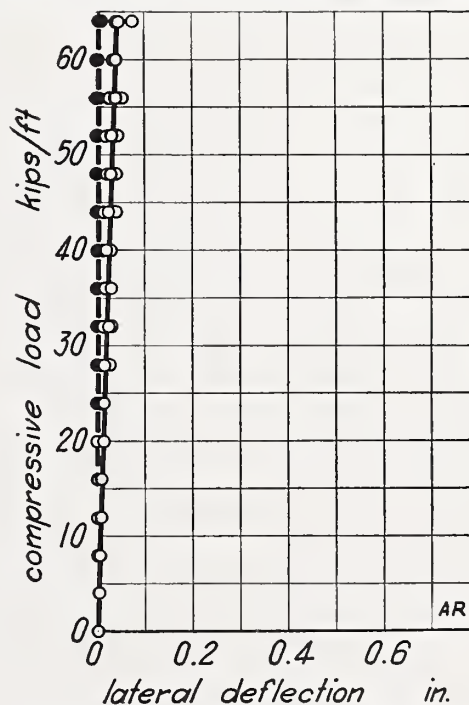
FIGURE 4.—*Compressive load on wall AR.*  
Load-lateral deflection (open circles) and load-lateral set (solid circles) results for specimens *AR-C1*, *C2*, and *C3*. The load was applied 2 in. from the inside face. The loads are in kips per foot of actual width of specimen. The deflections and sets are for a gage length of 7 ft 6 in., the gage length of the deflectometers.

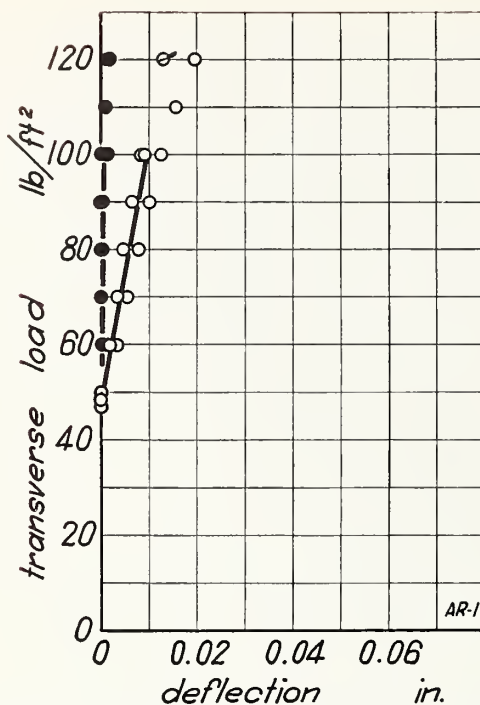
FIGURE 5.—Transverse load on wall AR, load applied to inside face.

The results are shown in table 2 and in figure 5 for wall specimens *AR-T1*, *T2*, and *T3*, loaded on the inside face, and in figure 6 for wall specimens *AR-T4*, *T5*, and *T6*, loaded on the outside face.

Load-deflection (open circles) and load-set (solid circles) results for specimens AR-T1, T2, and T3 on the span 7 ft 6 in.

Specimens T1, T2, and T3 failed by rupturing transversely (across the specimen) at or between the loading rollers.

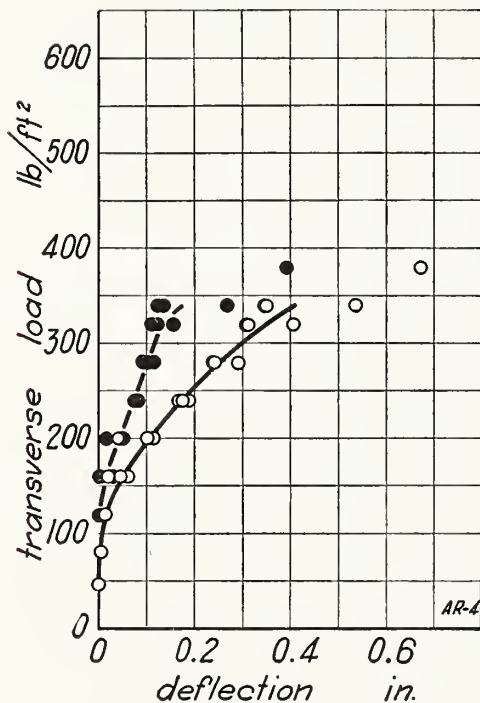
FIGURE 6.—Transverse load on wall AR, load applied to outside face.

Load-deflection (open circles) and load-set (solid circles) results for specimens AR-T4, T5, and T6 on the span 7 ft 6 in.

For specimens T4 and T6 at loads of 260 and 240 lb/ft<sup>2</sup> and deflections of 0.26 and 0.17 in., respectively, the inside face of each specimen cracked transversely (across the specimen). At the maximum loads each of the specimens T4, T5, and T6 failed by rupturing transversely (across the specimen) at or between the loading rollers.

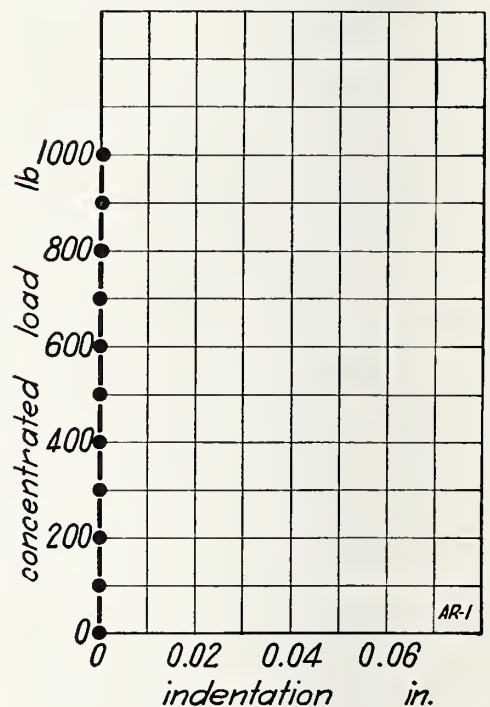
FIGURE 7.—Concentrated load on wall AR, load applied to inside face.

Load-indentation results for specimens AR-P1, P2, and P3.

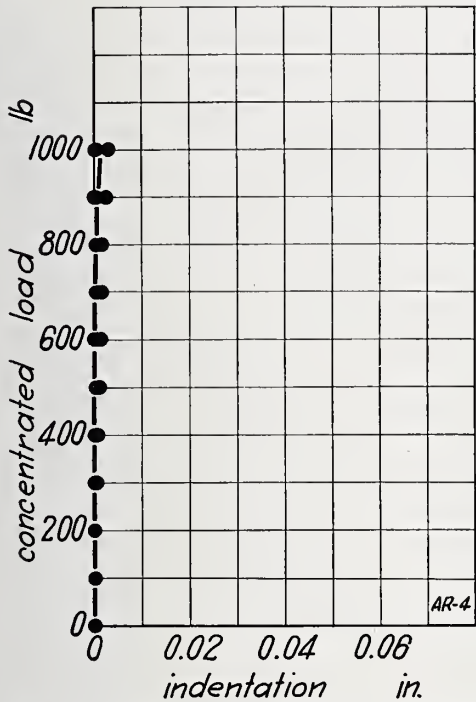
FIGURE 8.—Concentrated load on wall AR, load applied to outside face.

The concentrated loads were applied to the outside face of specimens *P4*, *P5*, and *P6* between two studs and at least 1½ ft from one end. The indentations after a load of 1,000 lb

Load-indentation results for specimens AR-*P4*, *P5*, and *P6*.

had been applied were 0.003, 0.000, and 0.000 in. for specimens *P4*, *P5*, and *P6*, respectively, and no other effect was observed.

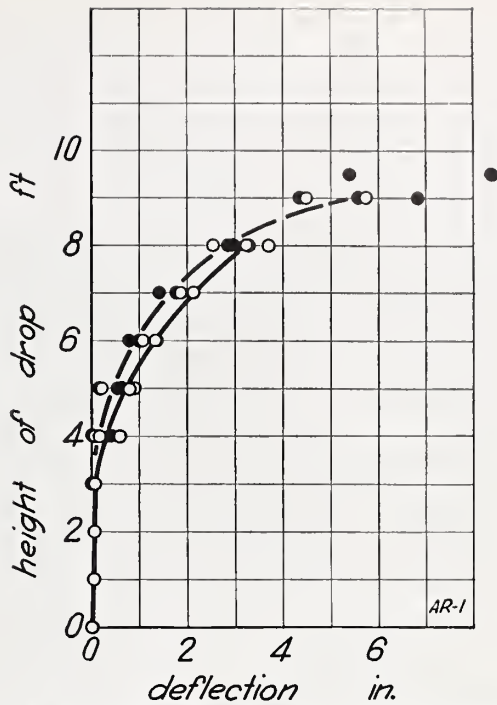
FIGURE 9.—Impact load on wall AR, load applied to inside face.

The impact loads were applied to the center of the inside face of specimens *I1*, *I2*, and *I3*, the sandbag striking midway between the two inner studs. At drops of 5, 4, and 3 ft and deflections of 0.20, 0.16, and 0.06 in. for specimens *I1*, *I2*, and *I3*, respectively, the outside face of each specimen failed by cracking transversely (across the specimen) at midspan. At drops of 8.5, 8.5, and 7.5 ft for specimens *I1*, *I2*, and *I3*, respectively, the inside face (face struck) of each

Height of drop-deflection (open circles) and height of drop-set (solid circles) results for specimens AR-*I1*, *I2*, and *I3* on the span 7 ft 6 in.

specimen cracked where the sandbag struck. At the maximum drops, specimens *I1* and *I2* failed by breaking in two at midspan. For specimen *I3* at a drop of 8.5 ft the inside face (face struck) failed by rupturing of the face where the sandbag struck, and at a drop of 10 ft

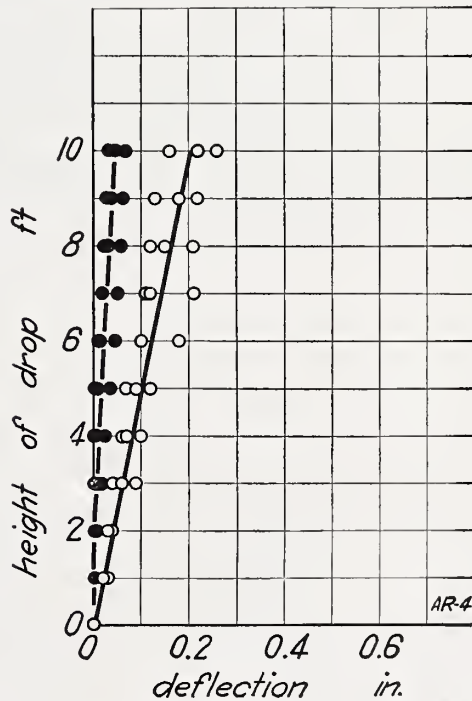
FIGURE 10.—Impact load on wall AR, load applied to outside face.

Height of drop-deflection (open circles) and height of drop-set (solid circles) results for specimens AR-*I4*, *I5*, and *I6* on the span 7 ft 6 in.

The impact loads were applied to the center of the outside face of specimens *I4*, *I5*, and *I6*, the sandbag striking midway between the two inner studs. At drops of 5 and 5.5 ft and deflections of 0.09 and 0.08 in. for specimens *I5* and *I6*, respectively, the inside face of each specimen cracked transversely (across the specimen) near midspan. The sets after a drop of 10 ft were 0.067, 0.046, and 0.032 in. for specimens *I4*, *I5*, and *I6*, respectively, and no other effect was observed.

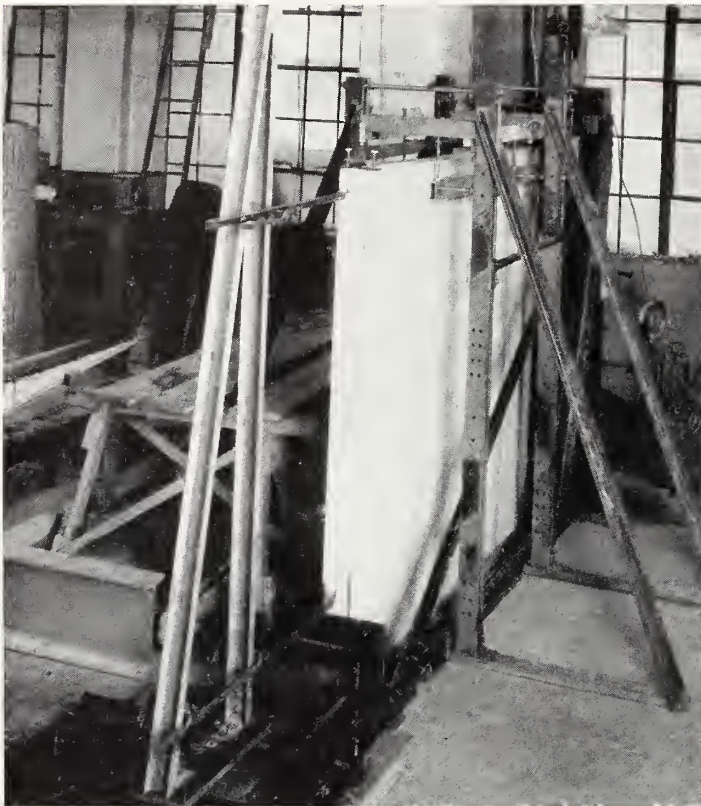
FIGURE 11.—Wall specimen *AR-R3* under racking load.

The sets after a load of 5.88 kips/ft had been applied were less than 0.01 in. for each of the specimens. For specimens *R1* and *R2* no other effect was observed, and for specimen *R3* only a slight crack about 1 ft long was observed near the center of the inside face.

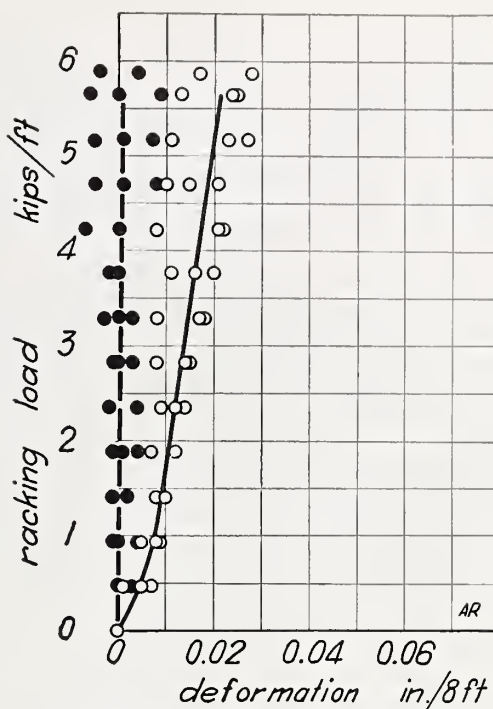
FIGURE 12.—Racking load on wall AR.

Load-deformation (open circles) and load-set (solid circles) results for specimens AR-R1, R2, and R3. The loads are in kips per foot of actual width of specimen.

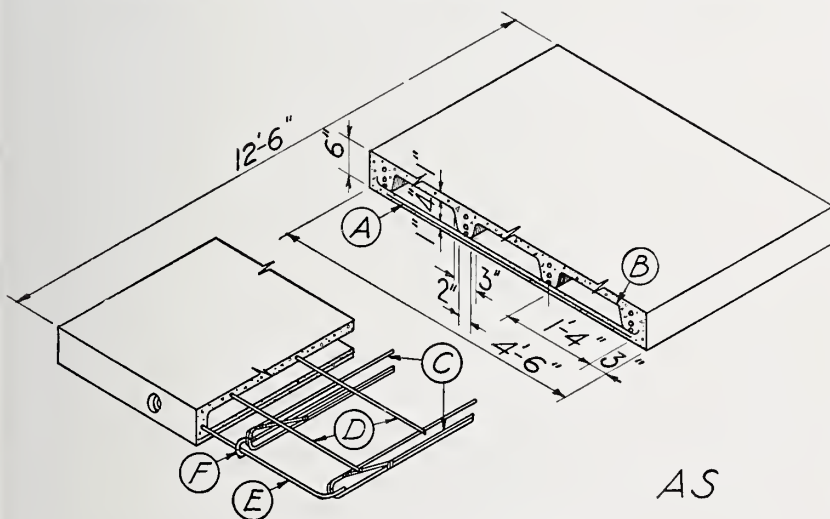
FIGURE 13.—Floor specimen AS.

*Metal-lath form.*—The metal-lath form, B, consisted of six strips of metal lath 6 ft 0 in. by 2 ft 0 in., and one strip 6 ft 0 in. by 1 ft 0 in. The length of the strips was at right angles to the length of the specimen. The strips overlapped about 2 in. and were shaped by dies to the form of the joists.

*Longitudinal reinforcement.*—The longitudinal reinforcement, C, consisted of three reinforcement bars in each joist fastened together by wire. The length of the assembled bars was 12 ft 2 in. for the two outer joists and 12 ft 0 in. for the two inner joists. The lowest bar of each assembly was a  $\frac{3}{8}$ -in. diam bar with each end bent upward 2 in., and placed with its center  $1\frac{1}{4}$  in. above the lower face of the specimen. A  $\frac{1}{2}$ -in. diam bar was placed just above the lowest bar, being bent diagonally upward starting about 1 ft from each end, extending about 2 in. along the top, then bent downward for about 2 in. at the ends. The top bar was  $\frac{3}{8}$  in. diam with its ends bent

*End reinforcement.*—The reinforcement, E, at each end was one  $\frac{3}{8}$ -in. diam bar, 4 ft 8 in. long, having a 3-in. right-angle bend at each end. The bars were at mid-thickness and about 1 in. from the ends.

*Eyes.*—There were two lifting eyes, F, at each end of the specimen. The eyes were  $\frac{1}{2}$ -in. diam reinforcement bars, 3 ft 0 in. long, with one end bent to a ring 3 in. diam. The eyes were fastened to the reinforcement for the two inner joists by wire. Each eye was in a recess in the end of the specimen.

A, welded wire fabric; B, metal-lath form; C, longitudinal reinforcement; D, lateral reinforcement; E, end reinforcement; F, eye.

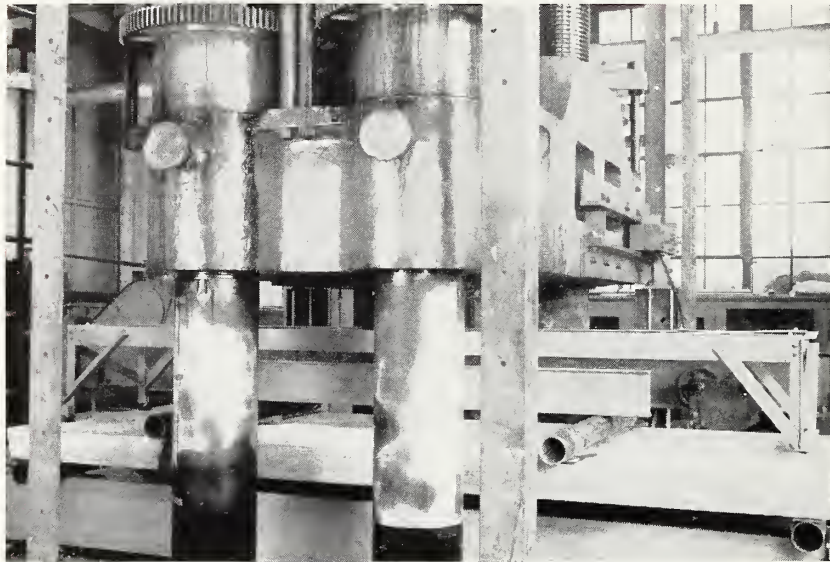
FIGURE 14.—Floor specimen *AS-T2* under transverse load.

For each of the specimens the lower face cracked transversely across the specimen at several places between the loading rollers. The first cracks occurred at loads of 120, 100, and 60 lb/ft<sup>2</sup> and deflections of 0.45, 0.43, and 0.19 in. for specimens *T1*, *T2*, and *T3*, respectively. At the maximum loads each of the specimens failed by rupturing transversely (across the specimen) at one or more places between the loading rollers.

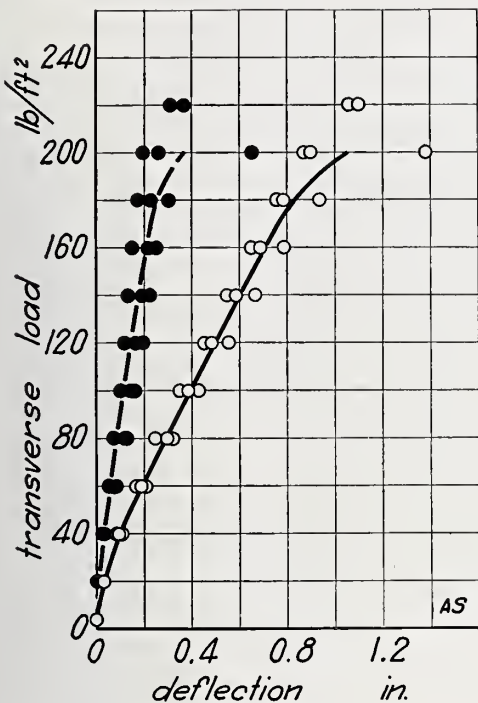
FIGURE 15.—Transverse load on floor AS.  
Load-deflection (open circles) and load-set (solid circles) results for specimens AS-T1, T2, and T3 on the span 12 ft 0 in.

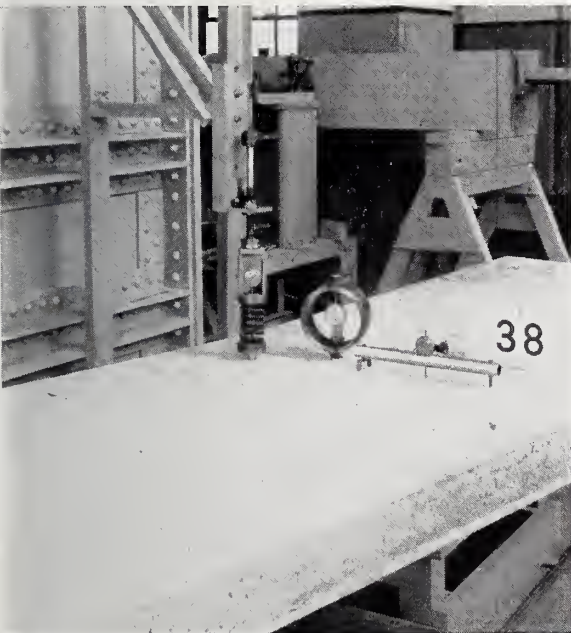
FIGURE 16.—Floor specimen AS-P1 under concentrated load.

The concentrated loads were applied to the upper face of each specimen between two studs and about midlength. The indentations after a load of 1,000 lb had been applied were 0.001, 0.001, and 0.000 in. for specimens *P1*, *P2*, and *P3*, respectively, and no other effect was observed.

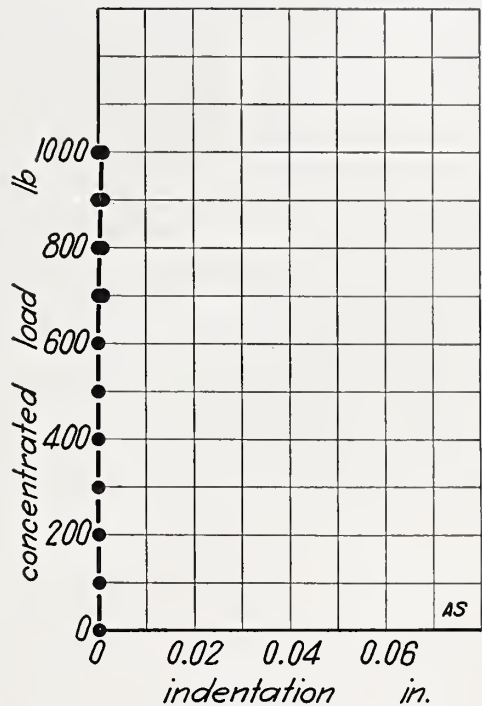
FIGURE 17.—Concentrated load on floor AS.  
Load-indentation results for specimens AS-P1, P2, and P3.

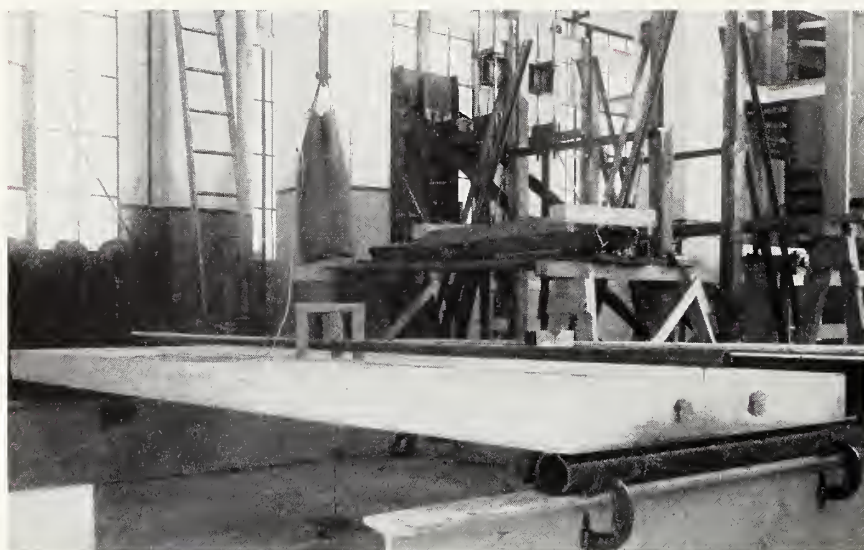
FIGURE 18.—Floor specimen *AS-13* during the impact test.

Floor specimen *AS-I3* during the impact test is shown in figure 18. The results for floor specimens *AS-I1*, *I2*, and *I3* are shown in table 3 and in figure 19.

The impact loads were applied to the upper face of each specimen, the sandbag striking midway between the two inner studs. At

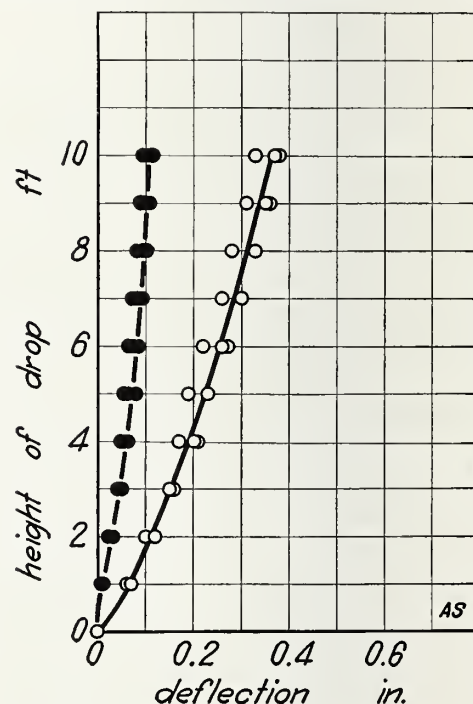
drops of 5.5 and 8.5 ft and deflections of 0.24 and 0.28 in. for specimens *I1* and *I2*, respectively, the lower face of each specimen cracked transversely (across the specimen) near midspan. The sets after a drop of 10 ft were 0.108, 0.095, and 0.114 in. for specimens *I4*, *I5*, and *I6*, respectively, and no other effect was observed.

FIGURE 19.—Impact load on floor *AS*.  
Height of drop-deflection (open circles) and height of drop-set (solid circles) results for specimens *AS-II*, *I2*, and *I3* on the span 12 ft 0 in.

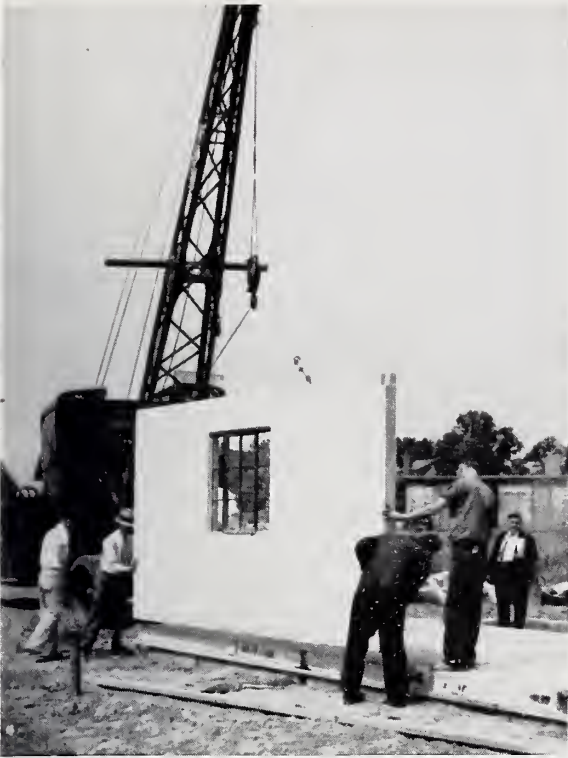
FIGURE 20.—Erecting “Twachtman” wall panel by means of a crane truck.

truck, as shown in figure 20. When delivered, the panels were completely equipped with hardware, openings for pipe and conduit, etc., and required only to be assembled and to have the joints between panels sealed.
